### **Current Status:**

Slight degradation was visible in delivered maximum power since two years, but this was assumed to be caused by dirty panels

After more measurements it became clear that „11 thirds“ of the panels deliver no power

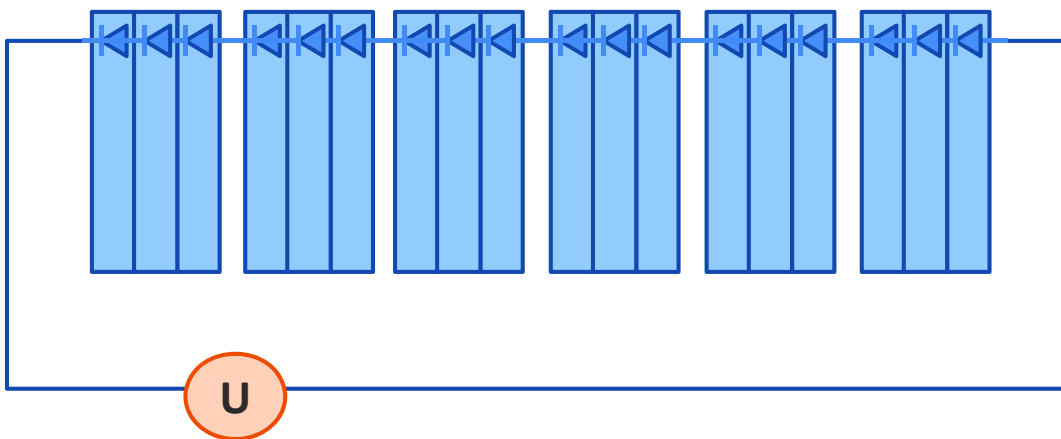
Voltage on substring measured with no load

Sstring	Umeas	Deficit
A 6P	198V	-6V
B 6P	190V	-14V
C 6P	192V	-12V
D 6P	204V	Reference, assumed good
E 6P	197V	-7V
F 9P	310V	+4V

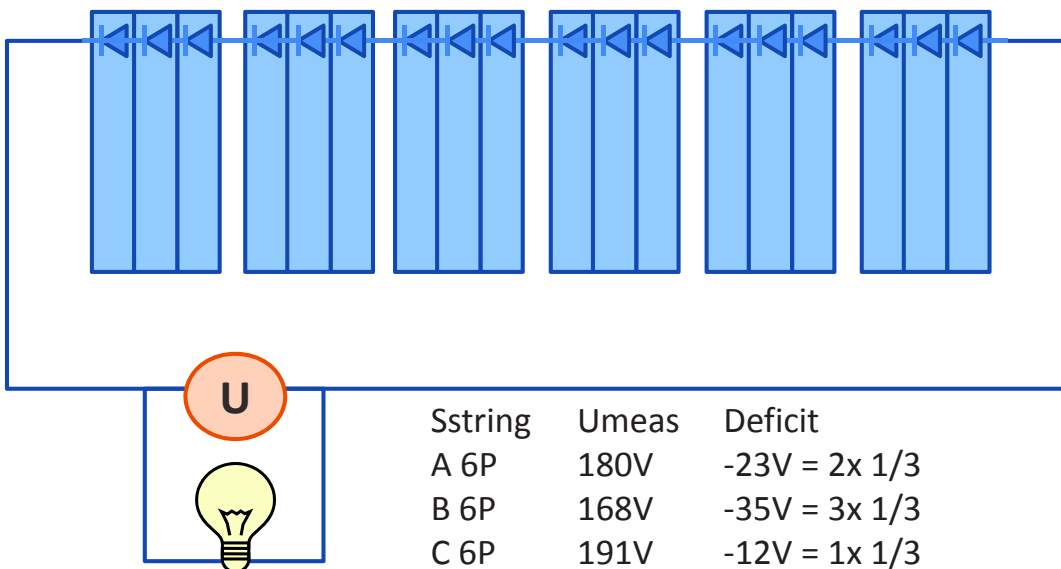
Voltage on substring measured **with 40 W lightbulb as load**

Sstring	Umeas	Deficit
A 6P	180V	-23V = 2x 1/3
B 6P	168V	-35V = 3x 1/3
C 6P	191V	-12V = 1x 1/3
D 6P	203V	Reference, assumed good
E 6P	170V	-33V = 3x 1/3
F 9P	284V	-21V = 2x 1/3

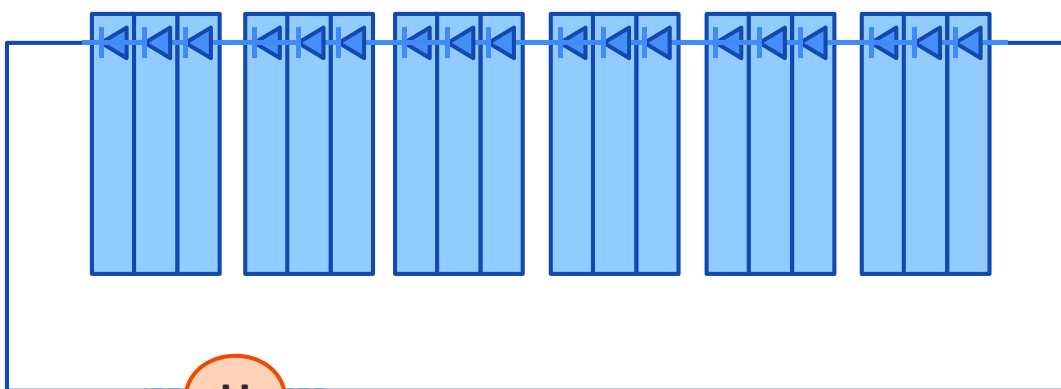
Voltage on substring measured with **40 W lightbulb as load & no load**

Sstring	Umeas Load	Umeas NoLoad
A 6P	180V	198V
B 6P	168V	190V
C 6P	191V	192V
D 6P	203V	204V
E 6P	170V	197V
F 9P	284V	310V

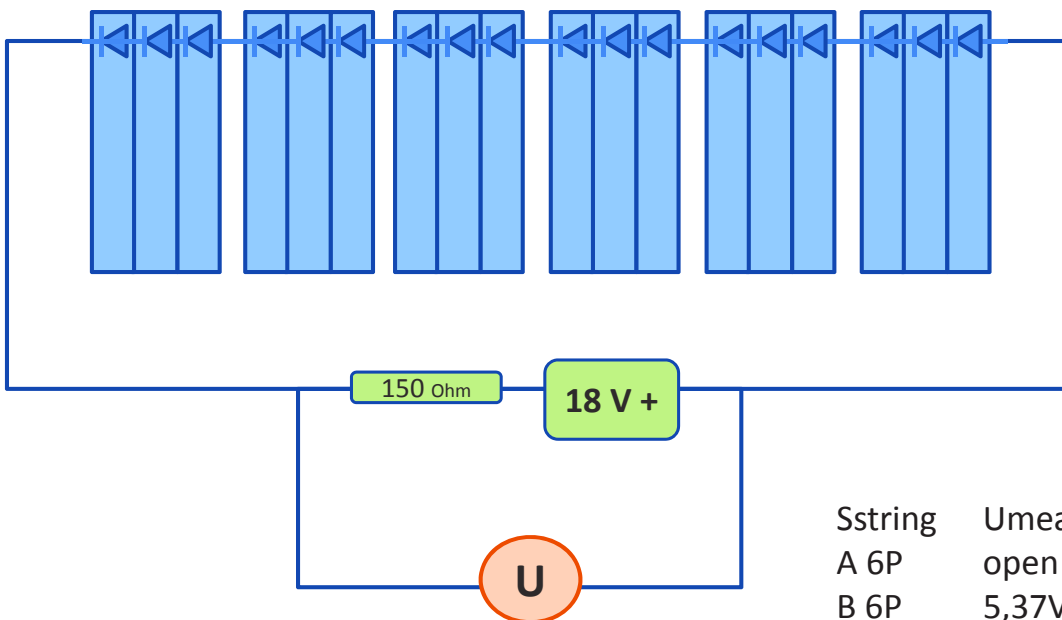
Bypass Diode Voltages on substring measured with auxiliary power

Typically 0,295 V per Diode at about 80mA

Sstring	Umeas	
A 6P	open	Defective
B 6P	5,37V	OK
C 6P	5,32V	OK
D 6P	5,30V	OK
E 6P	5,32V	OK
F 9P	7,82V	OK

As there is at least one open bypass diode inhibiting further checks, Substring A will be dismantled and each panel will be checked in detail, Thermographic checks show there two suspect panels

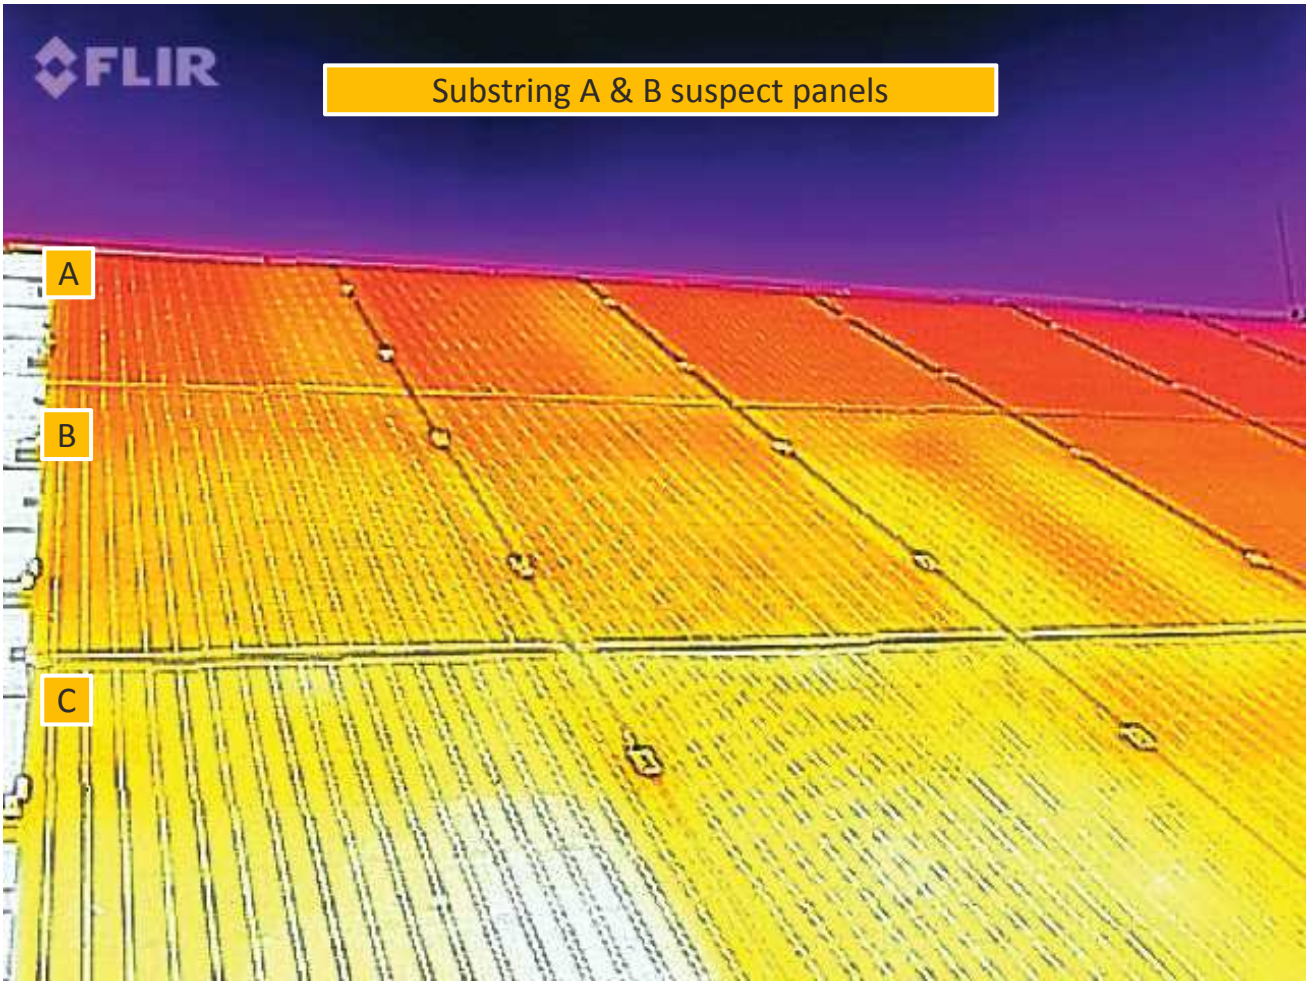
**Southside  
Defects  
Thermal ID**

Substring A & B suspect panels

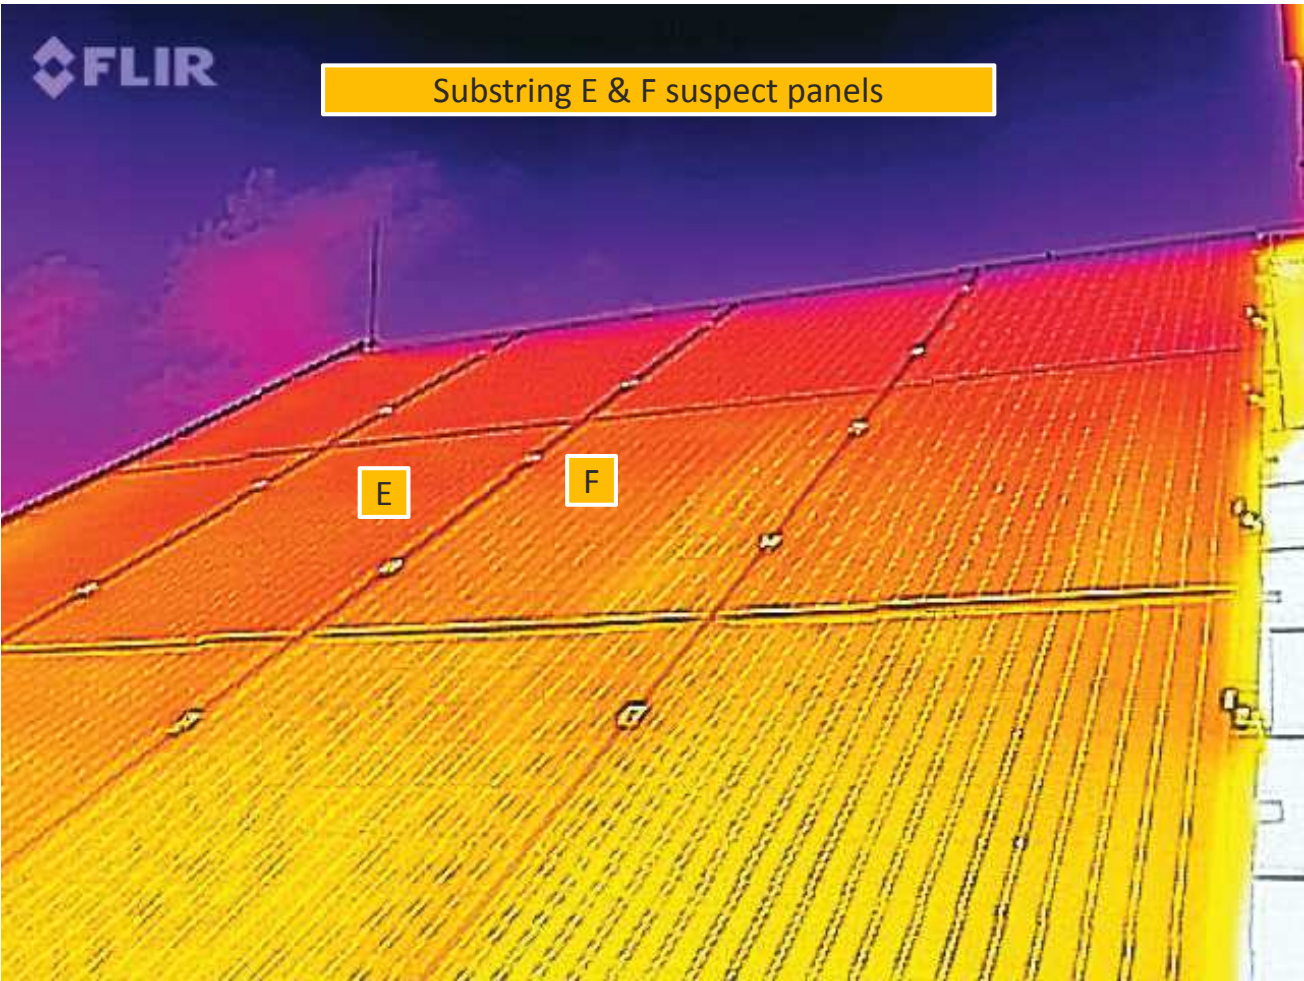
Substring E & F suspect panels

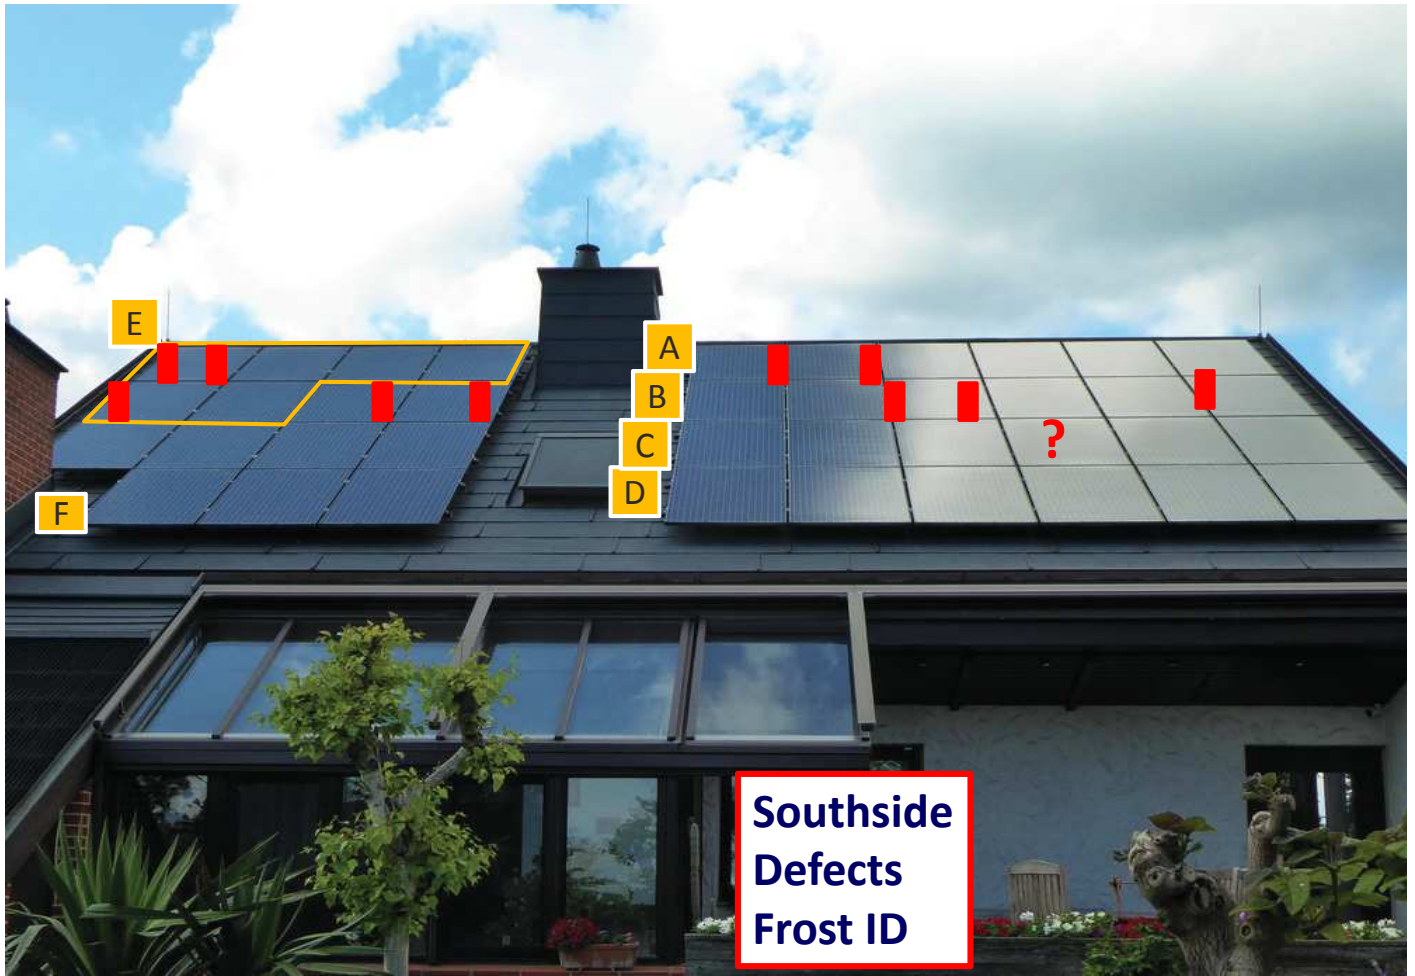
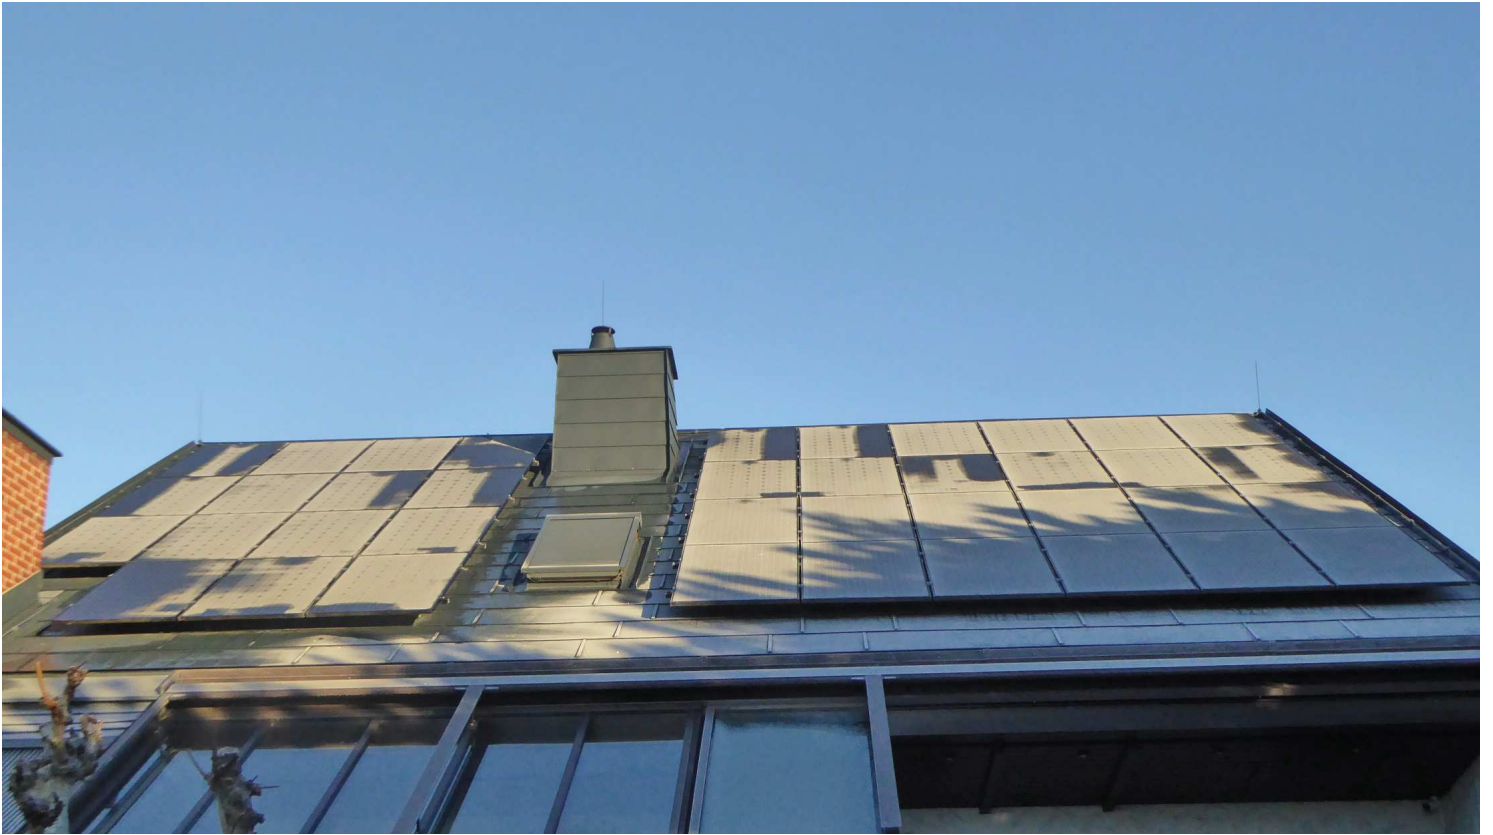
A Winter day with a perfect frost layer and full sun verified results of thermographic check, (except SS C,D in the shadow)

Current estimate is that 9 panels are partial defective (33% to 66%)  
 $11 \times 33\% = 900$  WP Performance loss
