### **Current Status:**

Slight degradation was visible in delivered maximum power since two years, but this was assumed to be caused by dirty panels

After more measurements it became clear that „11 thirds“ of the panels deliver no power

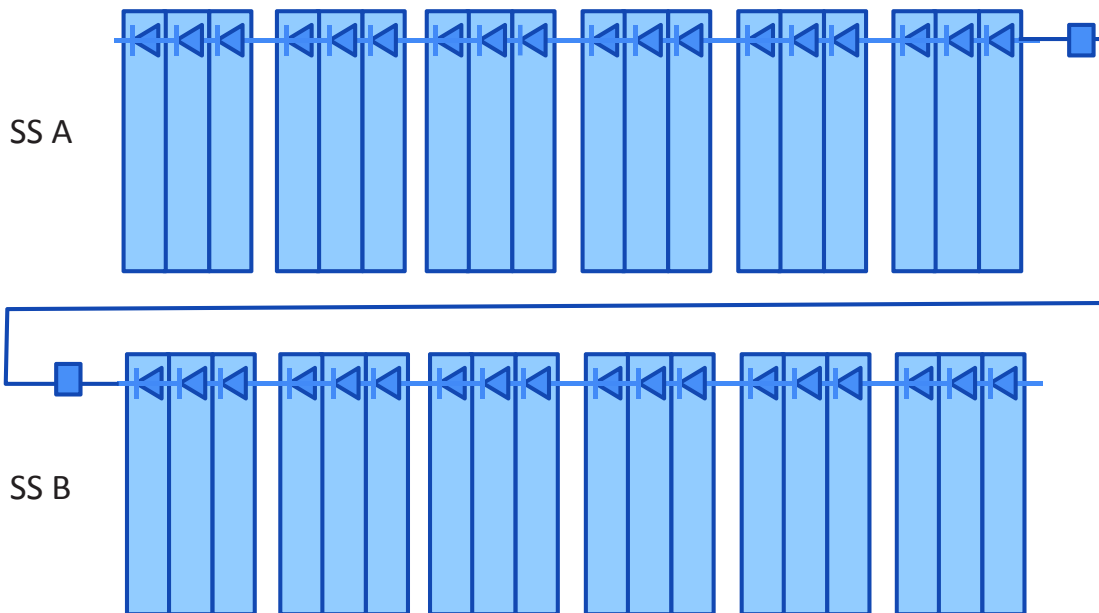
For easier troubleshooting each inverter string is built from two „substrings“  
Typically 6 Panels, only one substring has 9 panels

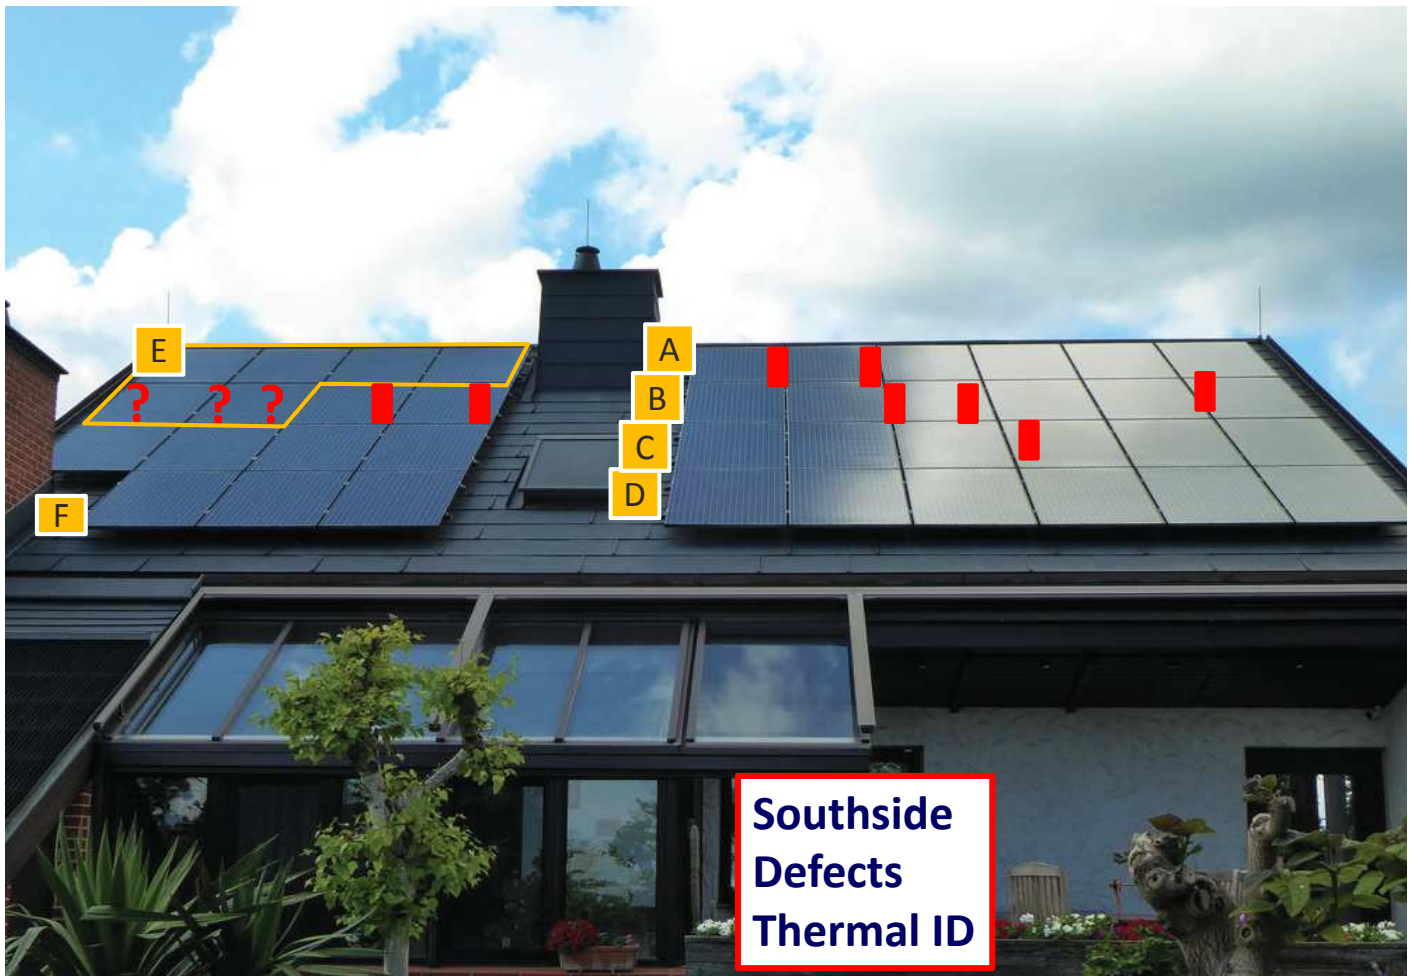
**Southside  
Defects  
Thermal ID**

Multiple thermographic checks showed some suspect panels, but this is not 100% accurate without special equipment

A Winter day with a perfect frost layer and full sun verified results of thermographic check, (except SS C,D in the shadow)

Current estimate is that 9 panels are partial defective (33% to 66%)  
 $11 \times 33\% = 900$  WP Performance loss
