System Error: 08:YZ (T1120/T1120ps/T620 ONLY)

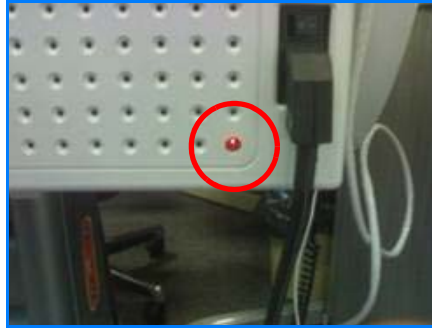
Corrective Action: The LEDs of the formatter (visible through the cover) and the power supply can help you troubleshoot a problem when the Front Panel is blank. The following image shows the Power Supply LED, looking through the cover.

Use the following table to interpret the LEDs and find the source of the problem. Remember that you should read these LEDs when you push the **Power** button.

Power supply LED	Formatter 1 LED	Formatter 2 LED	Formatter 3 LED	Front-panel status	Part to change
1	Off ○	Off ○	Off ○	Off ○	Off ○	Power supply. Page 6-209
2	On ●	Off ○	Off ○	Off ○	Off ○	Main PCA. Page 6-209

3	On ●	On ●	Off ○	Off ○	n/a	Formatter. Page 6-204
4	On ●	*Flashing*	Off ○	Off ○	n/a	Hard Disk Drive. Page 6-204
5	On ●	On ●	*Flashing*	Off ○	n/a	Hard Disk Drive. Page 6-204
6	On ●	On ●	On ●	Off ○	n/a	1. Formatter. Page 6-204 2. Main PCA. Page 6-209
7	On ●	On ●	On ●	*Flashing*	n/a	Main PCA. Page 6-209
8	On ●	On ●	On ●	On ●	Front-panel light on	First check the front panel. Page 6-47 If necessary, check the Main PCA. Page 6-209 Then check the front-panel cable. Page 6-47
9	On ●	On ●	On ●	On ●	Off ○	Check the front-panel cable connection. If necessary, replace the front-panel cable. Page 6-47

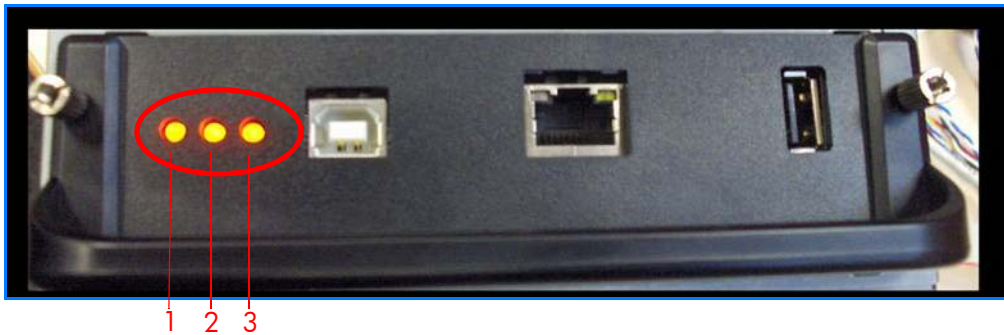
The following image shows the Formatter LEDs, which should be marked 1, 2, and 3.
